Tips for Extending Equipment Life

TRIOSIM
CORPORATION

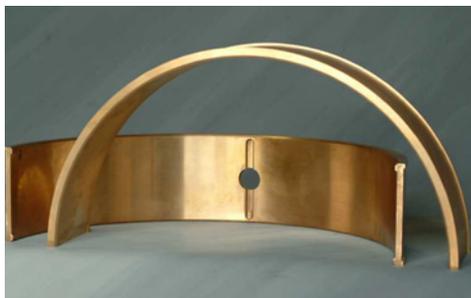
Bushings that are badly worn will cause excessive float of the drum. This disrupts the oil seal's ability to maintain contact with the lower surface of the trunnion. The result is oil loss and water migration from the vat.

Replace Worn Bushings

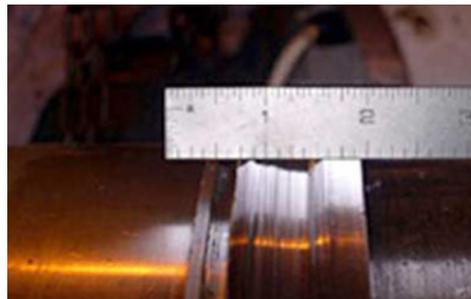
Damage shown on the inner seal land is abrasion and grooving caused by conventional seals that use retaining springs.

Too often, the spring used in conventional oil seals becomes displaced. The result is a badly grooved trunnion surface.

The Triosim Premium Seal promotes an enhanced interference fit without the use of a spring, imposing less wear on equipment. It seals effectively on trunnion surfaces that have been severely worn, including badly grooved surfaces. The result is reduced oil loss, less downtime and streamlined gearcase maintenance.

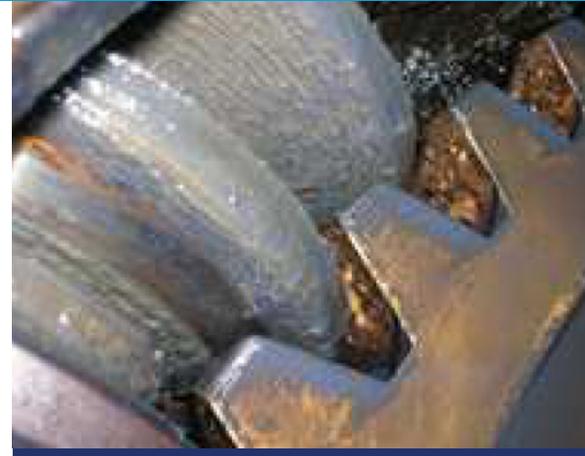
Gears above have been eroded by water contamination of the gearcase.

Properly installed on the trunnion, a flinger ring will prevent vat water from migrating into your gearcase. Water in the gearcase creates sludge - one of the major causes of gearcase overheating. Super heated oil actually attacks bronze resulting in damage to your bull gear.
